Asbestos, Lead-Based Paint, and Universal Waste Survey

**SDCCU Stadium
9449 Friars Road
San Diego, California**

**Aurora Industrial Hygiene
9666 Businesspark Ave, Suite 102
San Diego, CA 92131
Project #: 59053**

May 31, 2019

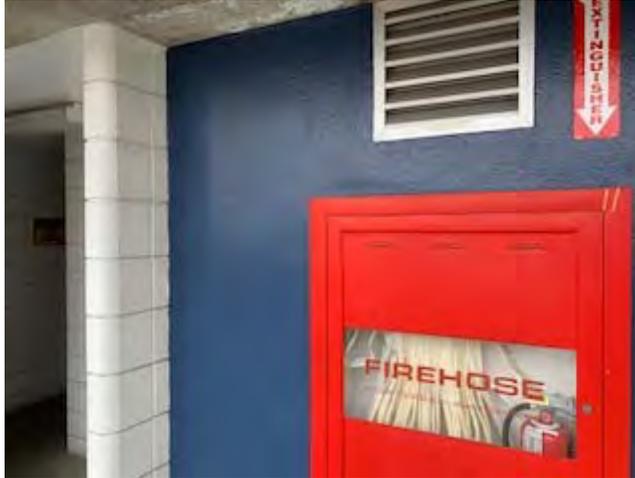
Photo 17. ACM: Blue stucco outside restrooms on View level.

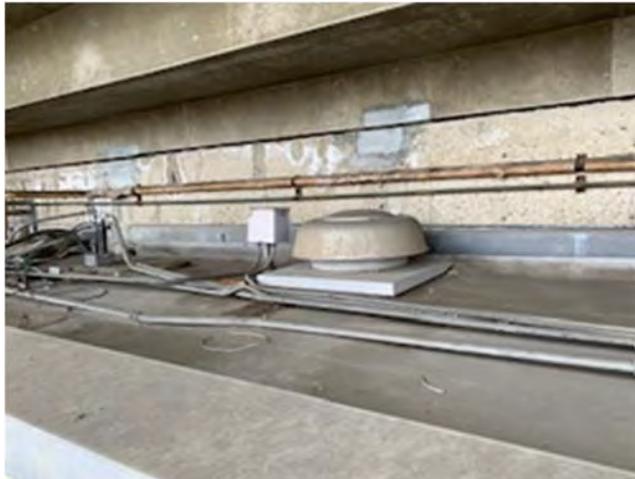
Photo 18. ACM: Rolled roofing on View level, Sections 2 – 40, above restrooms, concessions, and walkways.

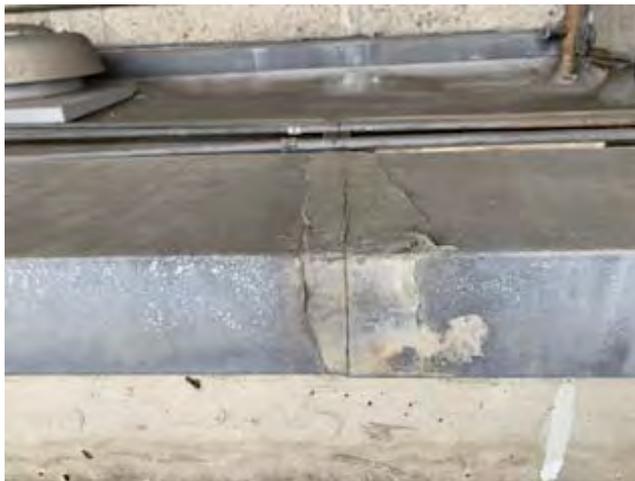
Photo 19. ACM: Roofing mastic, flashing and patches, on View level, Section 2 – 40.

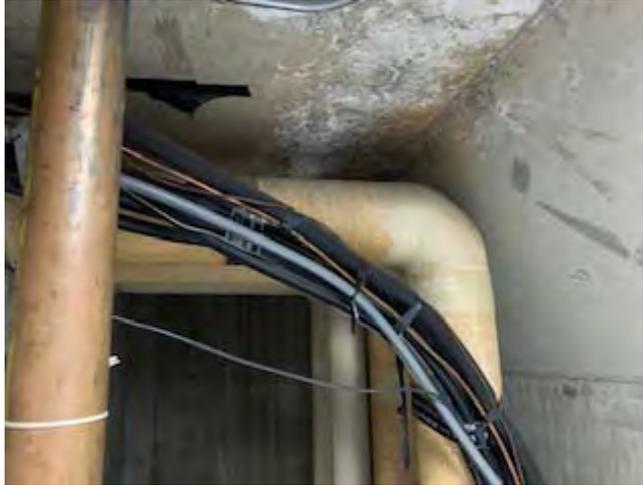
Photo 20. ACM: TSI elbows/fittings on View level.

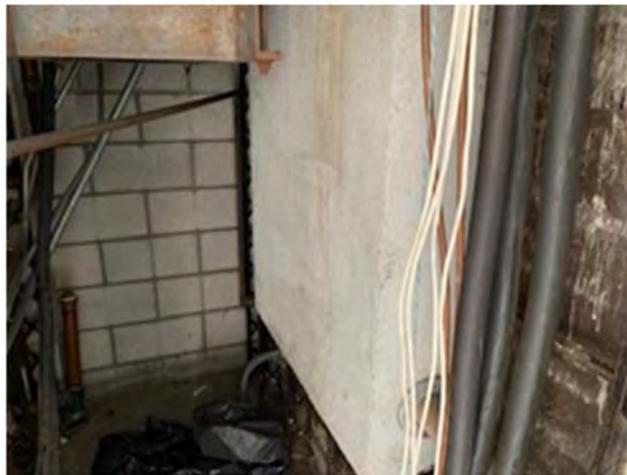
Photo 21. ACM: White stucco at fire hose boxes on View level.

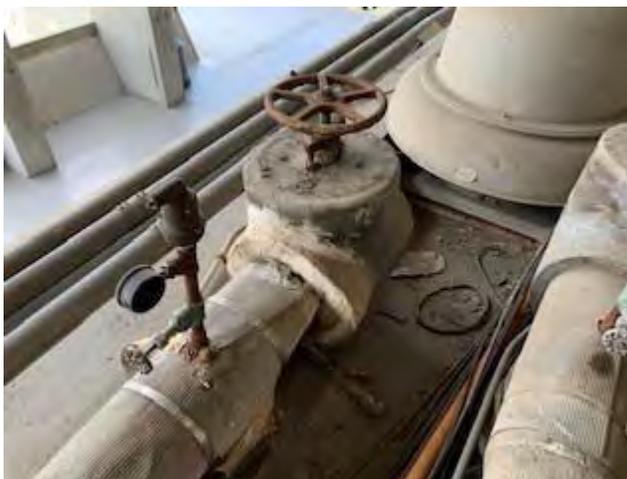
Photo 22. ACM: TSI elbows/fittings (large foam) on View level.

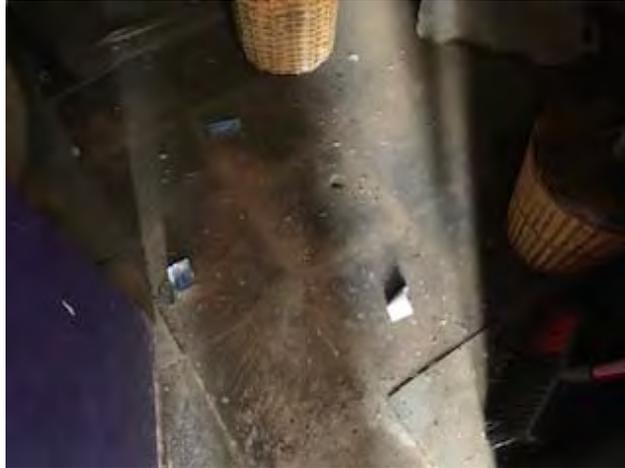
Photo 23. ACM: Floor tile mastic, partially covered with floor tile on View level.

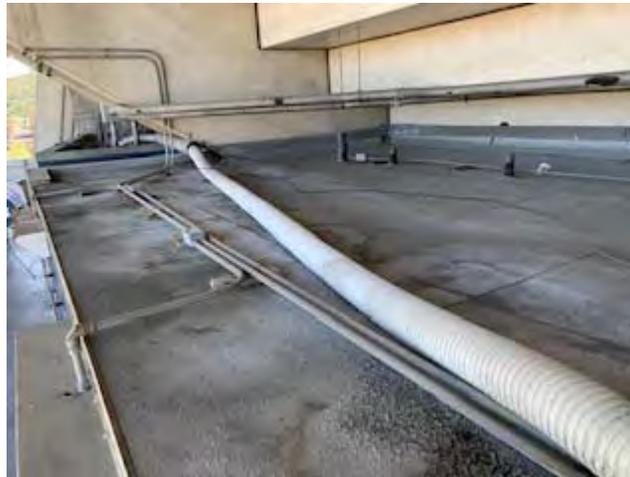
Photo 24. ACM: Roofing mastic at penetrations and patches, View level, section 41-49 and 54-61.

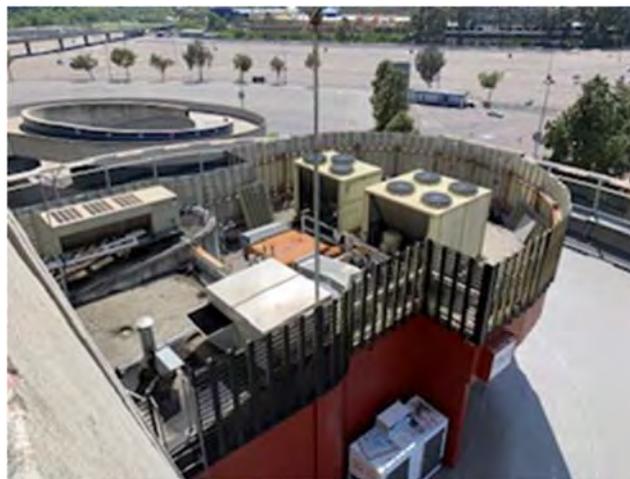
Photo 25. ACM: Rolled roofing and roofing mastic on Oggi's roof, View level.

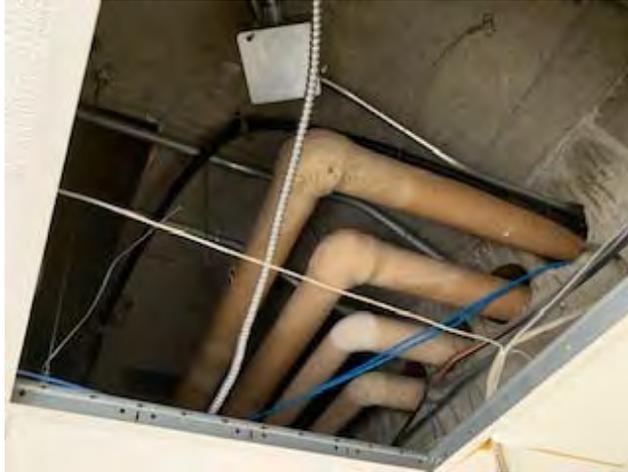
Photo 26. ACM: TSI elbows in pipe chase between restrooms and above ceilings, Press level.

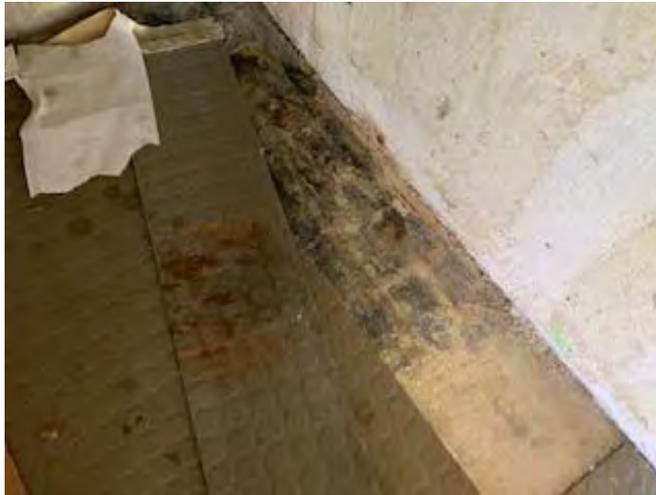
Photo 27. ACM: Floor tile mastic in Section 14 closet on Club level.

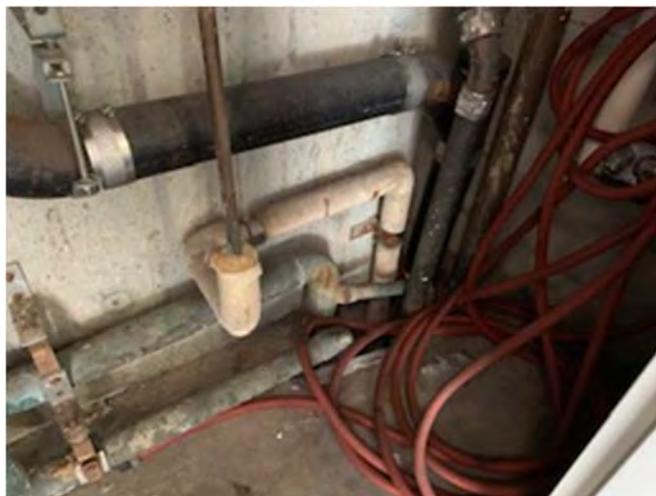
Photo 28. ACM: TSI elbow in restroom closet on Club level.

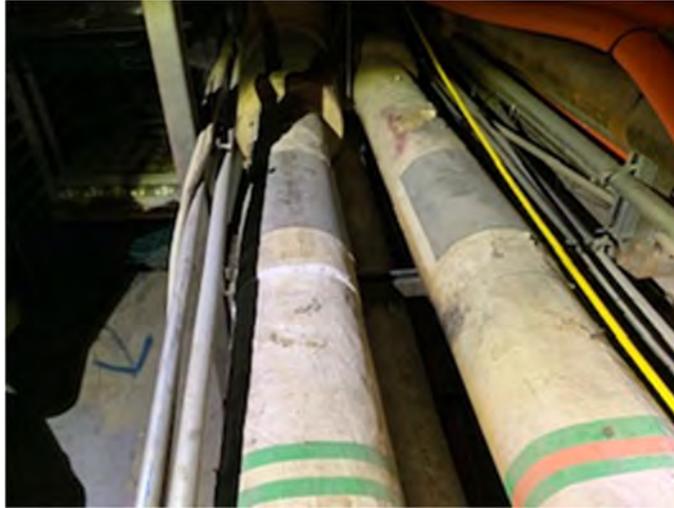
Photo 29. ACM: TSI straight under seats section 25, Club level.

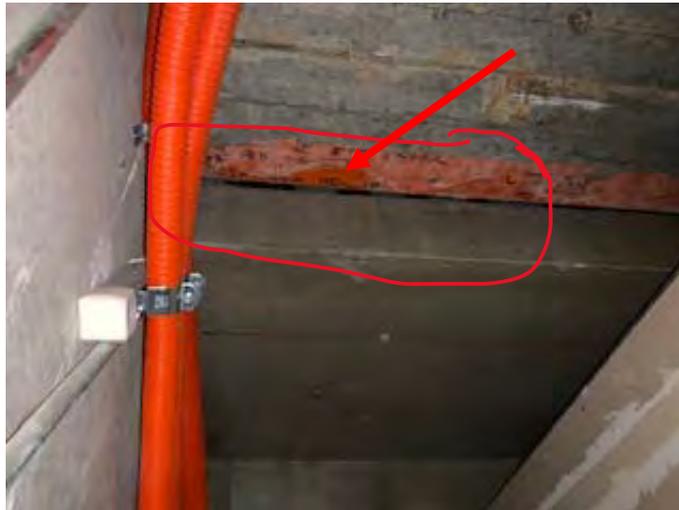
Photo 30. ACM: Mastic under seats between concrete slab and I-beam, sections 1 – 40, Club level.

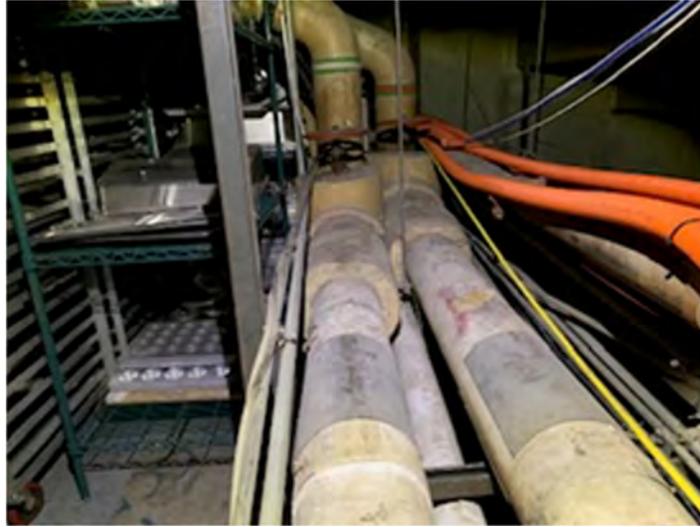
Photo 31. ACM: TSI fittings at hanger on foam straight run on Club level. Pipe chase is below seats. Foam insulation has an asbestos fitting every 10 feet; pipe also runs vertically from basement to View level.

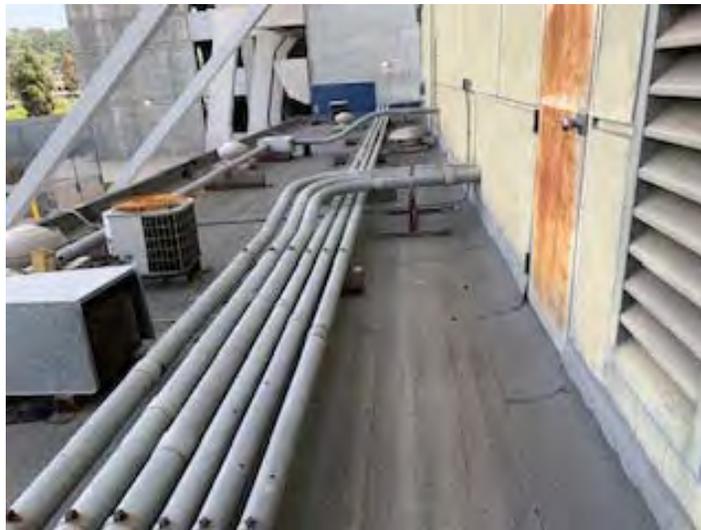
Photo 32. ACM: Rolled roofing on scoreboard building roof on Plaza level.

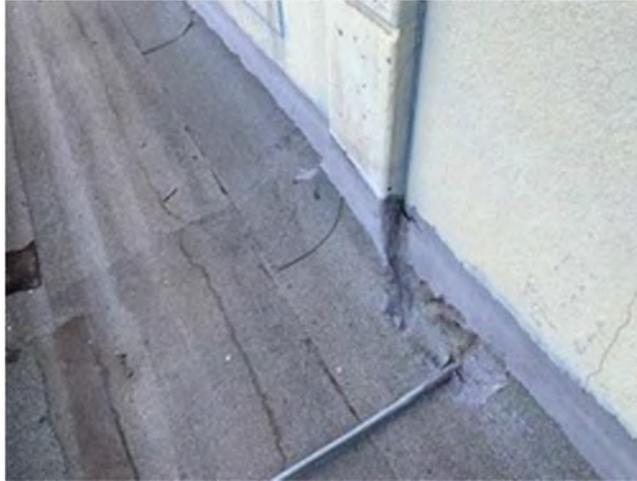
Photo 33. ACM: Roofing mastic at penetrations and patches on scoreboard building roof on Plaza level.

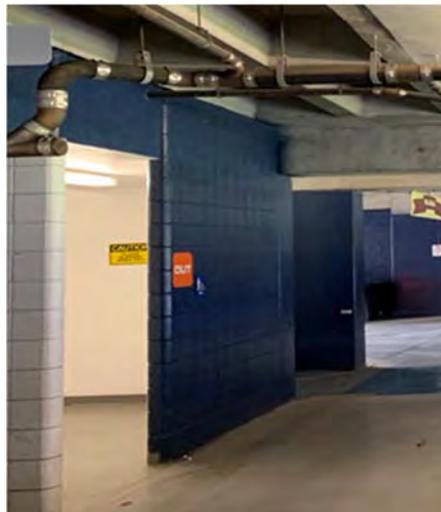
Photo 34. ACCM (Asbestos content between 0.1-1.0%): Stucco at ceilings at restroom entries on Plaza level.

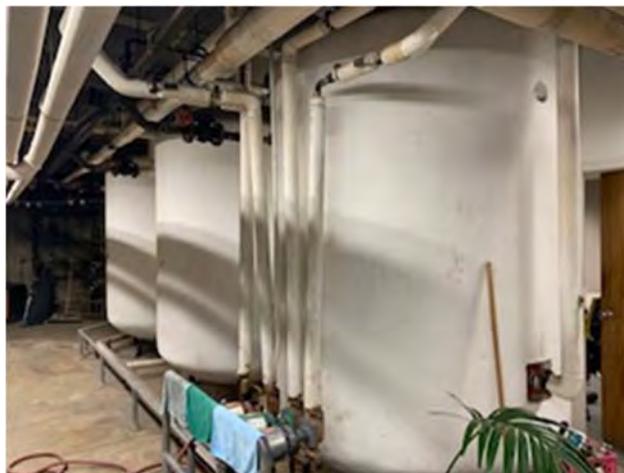
Photo 35. ACM: TSI tank insulation in HVAC room on level B2.
